TC/2-38-2087/2018-2

# REPORT

on trees at

The Pryors, East Heath Road,  
London, NW3 1BS

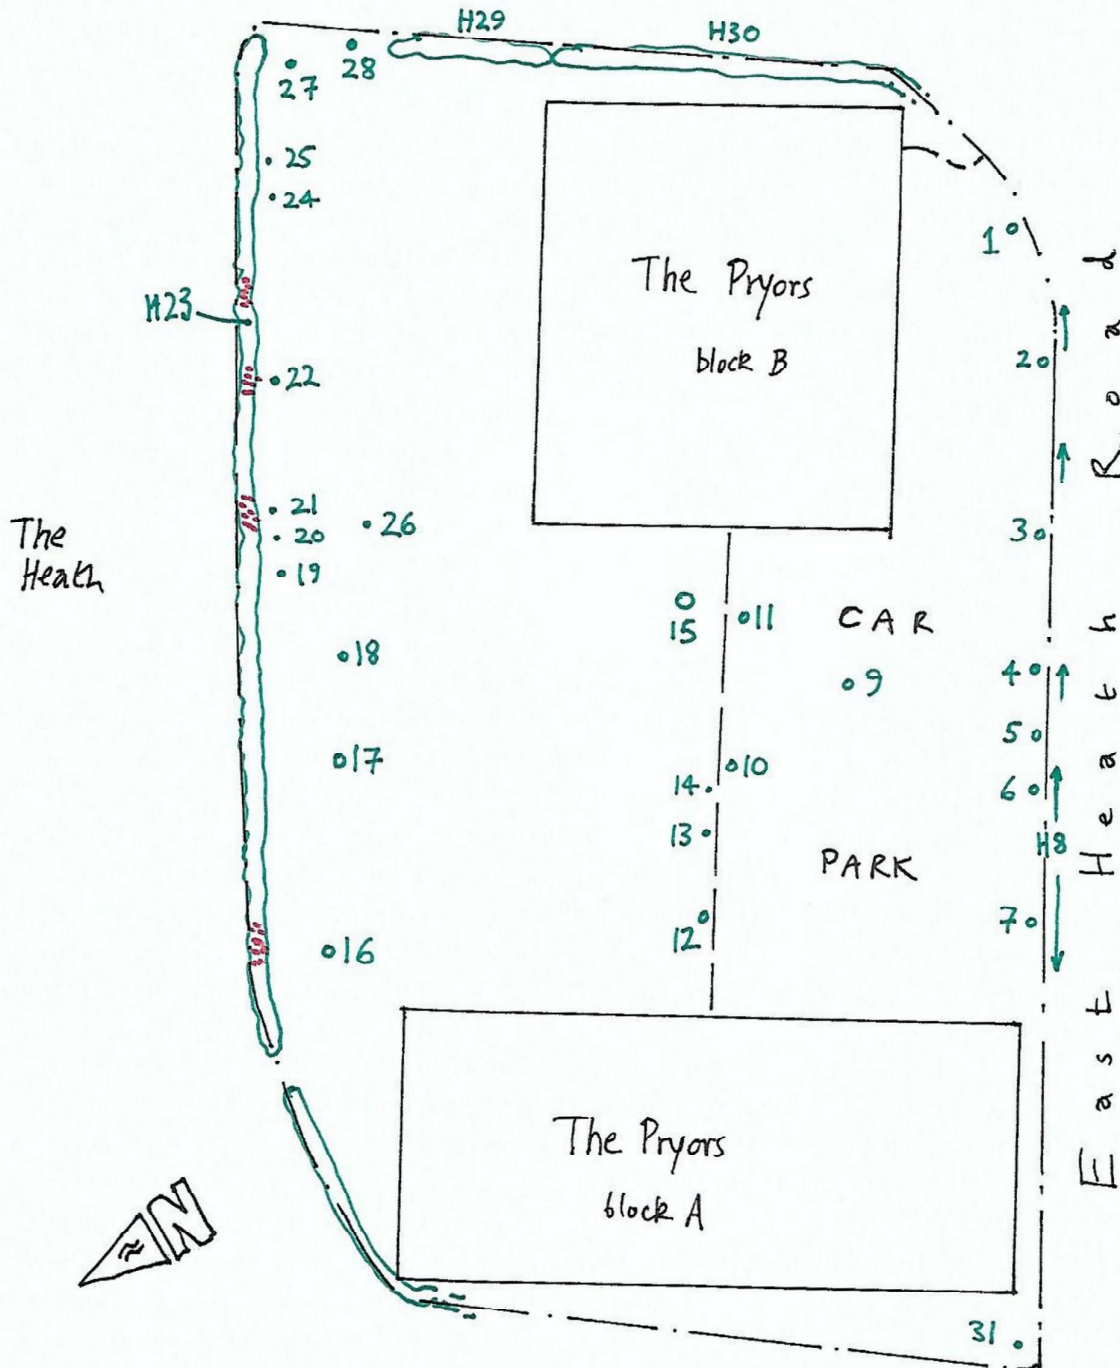
**09**  
**Plan**

NO.	TREE	HT.	TRUNK DIA.	COMMENTS / ACTION
H23	privet			Privet hedge appears to be dying (various locations marked red on plan). Suggest replace with yew and <i>Pyracantha</i> (thorny) mix.  Problem of discrete areas being affected by honey fungus, noted 2017, is evidently still present here. Insufficient apparently healthy plants on the margins of the infected zone are being removed. <i>Euonymus japonica</i> noted used as replacements which in the writer's experience is moderately resistant. Ensure that two or three apparently completely healthy privet hedge plants are removed and replaced at each location.
24	Swedish whitebeam	7.5m	156mm	Similar situation to trees 18, 19 and 20, but here the competition is with an English oak and a multi-stemmed lime tree growing on the Heath.
25	Swedish whitebeam	9m	202mm	
26	Dawyck beech	16m	378mm	
27	deodar	16m	508mm	NAD
28	birch	15m	380mm	NAD
H29	laurel hedge	1.5m	MS
