S127-J5-SFR-1

REPORT

The Pryors, East Heath Road, London NW3 1BS

(2nd August 2023)

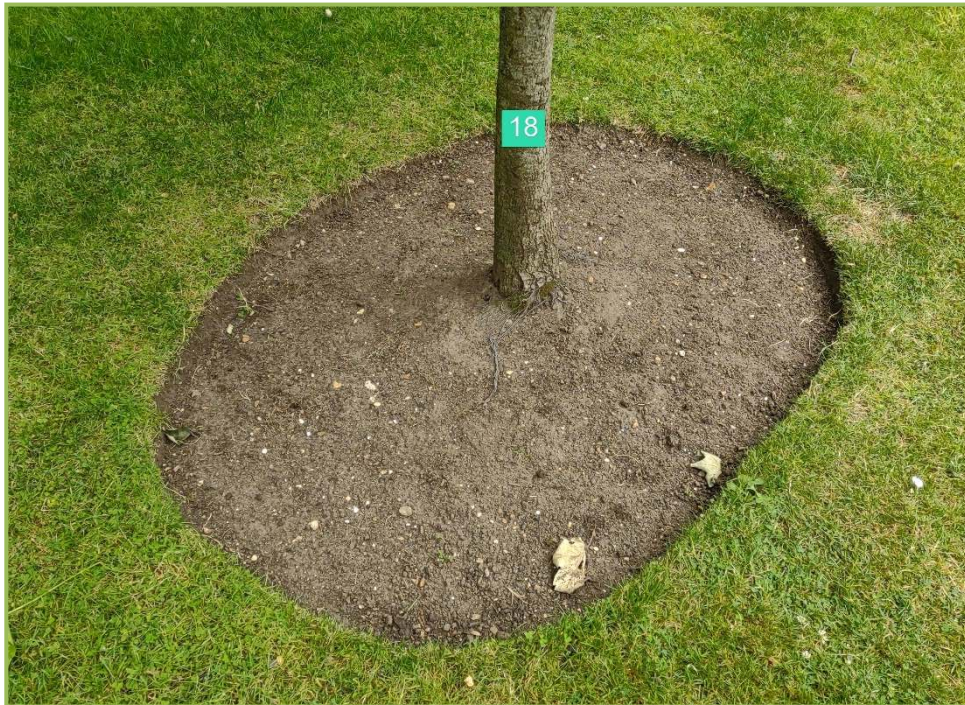
11 Photo

NO.	TREE	HT.	TRUNK DIA.	COMMENTS / ACTION	Urgency
18	<i>Liquidambar</i> spp.	7m	76mm	The growth rate of the tree seems to have slowed probably due to the mulch missing. Restore mulch to 75mm depth, with composted green waste.	
19	birch	9.5m	110mm/ 100mm	All three trees are to some extent affected by the adjacent large Turkey oak growing on the Heath.	
20	birch	7m	105mm/ 100mm		
21	birch	9.5m	170mm		
22	red oak	17.5m	438mm	Sited rather close to retaining wall.	
H23	privet				
24	Swedish whitebeam	7.5m	156mm	Gone. Replace; use a heat tolerant species, perhaps set south a little (into the lawn), e.g. <i>Oxydendron arboreum</i> .	Low (but desirable)
25	Swedish whitebeam	9m	210mm		
26	Dawyck beech	18m	440mm		
27	deodar	16m	578mm		
28	birch	15m	400mm		
H29	laurel hedge	1.5m	MS		
H30	privet hedge	1.8m	MS	Honey fungus does not appear to be infecting hedge in this location currently.	
31	winter flowering cherry	4m	90mm, 85mm	No access; poor form

Mulch, now noted here missing has a dramatic effect on rates of tree growth. Enlarging the tree pit by covering the grass with mulch out to say 1.5m from the trunk would be still better.
